DEPARTMENT OF TRANSPORTATION**DIVISION OF ENGINEERING SERVICES**

Contract #: 04-0120F4Cty: SF/ALA Rte: 80 PM: 13.2/13.9File #: 69.28**WELDING INSPECTION REPORT****Resident Engineer:**Pursell, Gary**Address:** 333 Burma Road**City:** Oakland, CA 94607**Report No:** WIR-000913**Date Inspected:** 19-Nov-2007**Project Name:** SAS Superstructure**OSM Arrival Time:** 630**Prime Contractor:** American Bridge/Fluor Enterprises, a JV**OSM Departure Time:** 1530**Contractor:** Zhenhua Port Machinery Company, Ltd (ZPMC), Changxing Island **Location:** Shanghai, China**CWI Name:** Xu Lefeng**CWI Present:** Yes No**Inspected CWI report:** Yes No N/A**Rod Oven in Use:** Yes No N/A**Electrode to specification:** Yes No N/A**Weld Procedures Followed:** Yes No N/A**Qualified Welders:** Yes No N/A**Verified Joint Fit-up:** Yes No N/A**Approved Drawings:** Yes No N/A**Approved WPS:** Yes No N/A**Delayed / Cancelled:** Yes No N/A**Bridge No:** 34-0006**Component:** Tower Mock-up and OBG**Summary of Items Observed:**

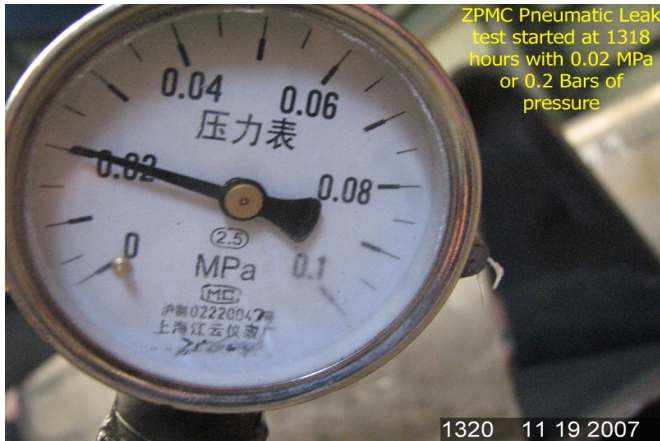
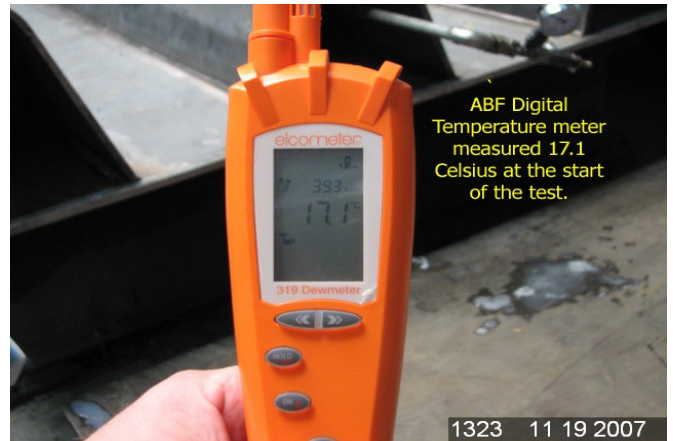
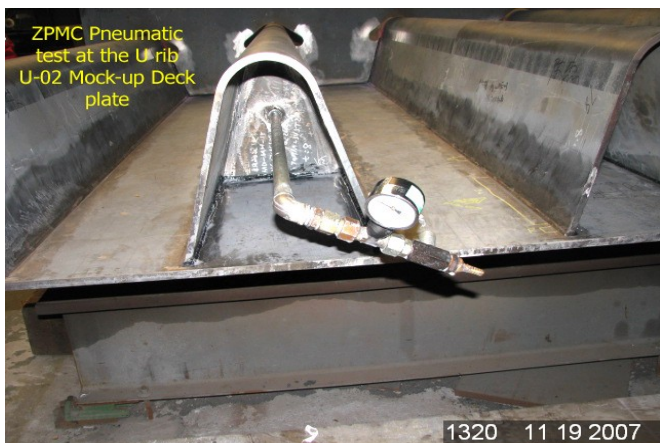
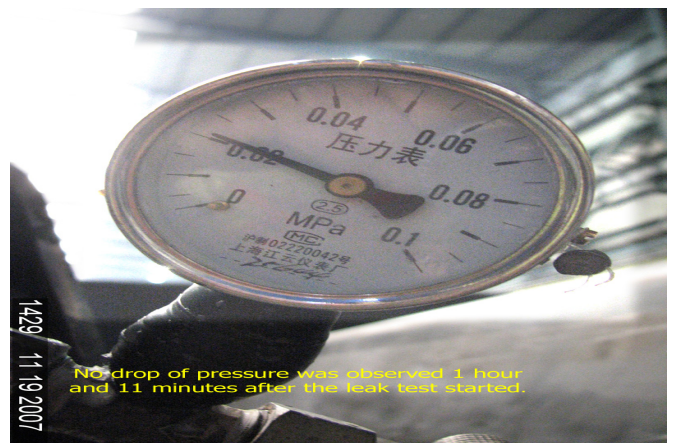
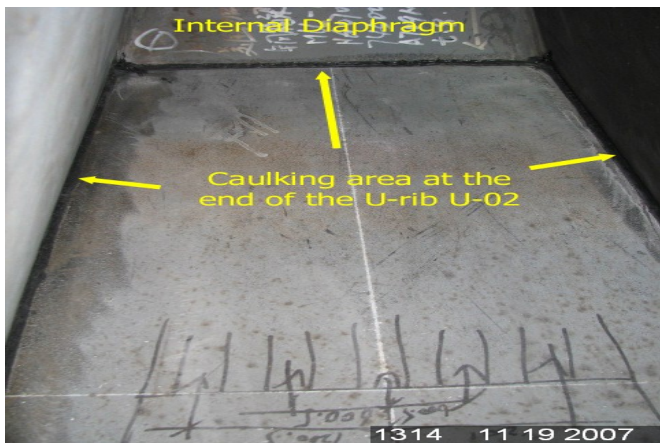
Item Description	WBS	Dwg No.	Status
1 OBG Mock-up deck plate Leak Test			
The QA inspector was at approximately 0800 hours in ZPMC Bay # 1 for the OBG Mock-up leak test scheduled on this date. The test was postponed according with ZPMC due to air leakage at the coupling on the 13,158 meters U-rib U-01. Later, ZPMC resolved to continue the air leak test on the next U-rib U-02 without repairing the air leakage on U-01. ZPMC pressurized the U-rib U-02 at approximately 1318 hours at 0.2 bars and no drop of pressure was noted at the end of the QA inspector shift. The photographs below depict the temperature and pressure measured by ZPMC, and others photos taken during the test.

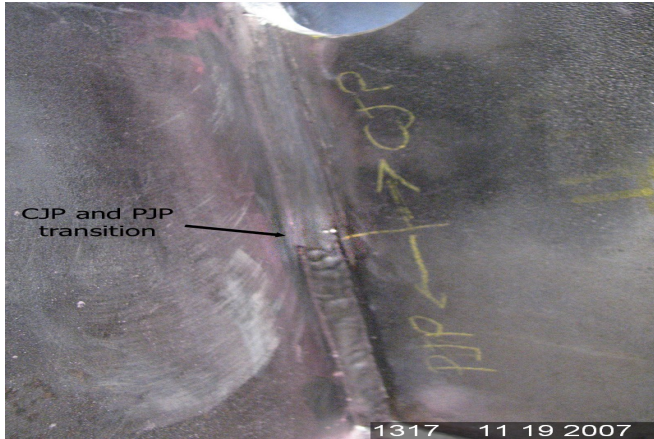
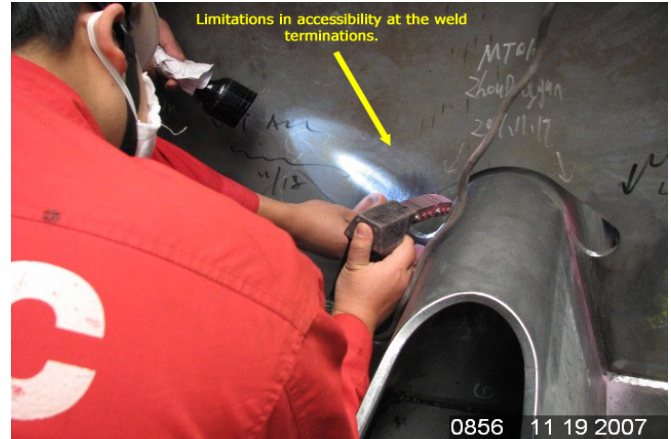
2 OBG Mock-up deck plate Magnetic particle testing (MT)

The QA inspector observed ZPMC performing MT at the junction of the U-ribs to the external diaphragm. The photographs below show ZPMC performing MT at the weld terminations (there are limited accessibility for the MT yoke at the ground areas).
